ARBORICULTURAL ASSESSMENT

Hollonds Street and Kiewa Crescent,
Mt. Beauty street tree assessment.

Prepared for: Francine Stacey | Project Officer | Alpine Shire Council

Thursday 26th February 2015

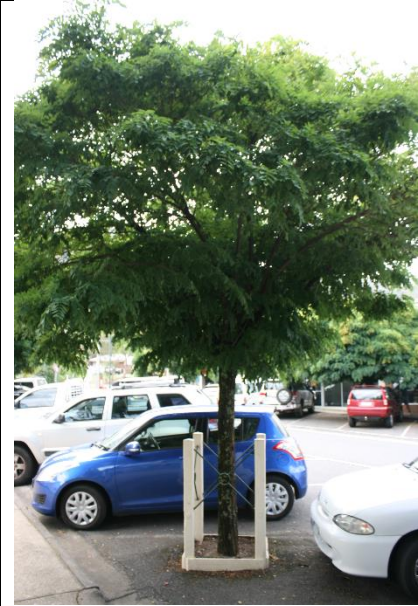
Tree 9: Illustrating the size and shape of the planter boxes.

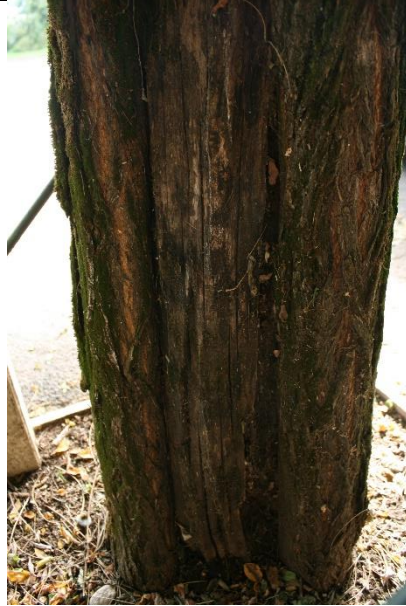
Tree 4: Basal trunk wound

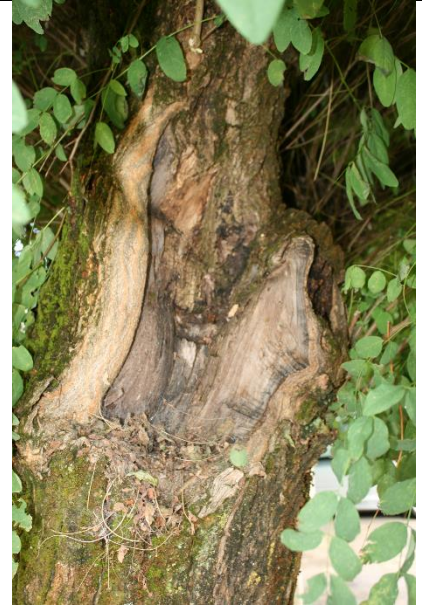
Tree 8: Previous branch failure

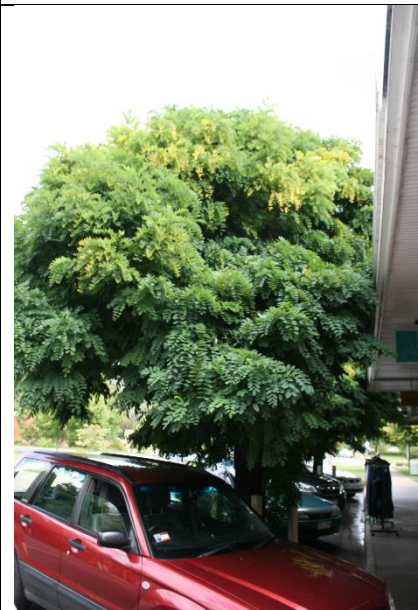
- 5.9 Almost all Mop Tops (those located in the proximity of buildings) were rubbing on adjacent roof guttering. In all circumstances the size of the branch contacting the gutter was less than 40mm \varnothing and was not causing substantial damage (no bending or cracking was evident).

Tree 16: Canopy overhanging the gutter

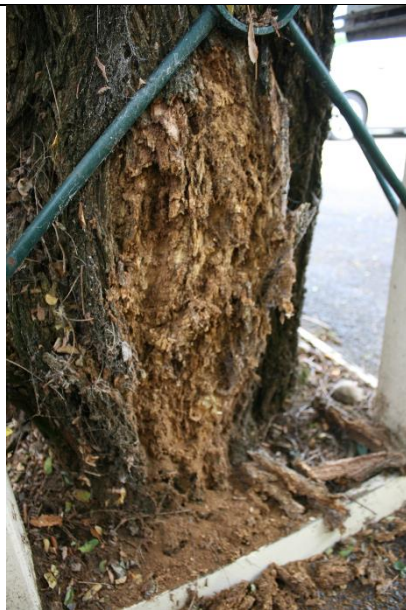
Tree 19: Basal decay and frass

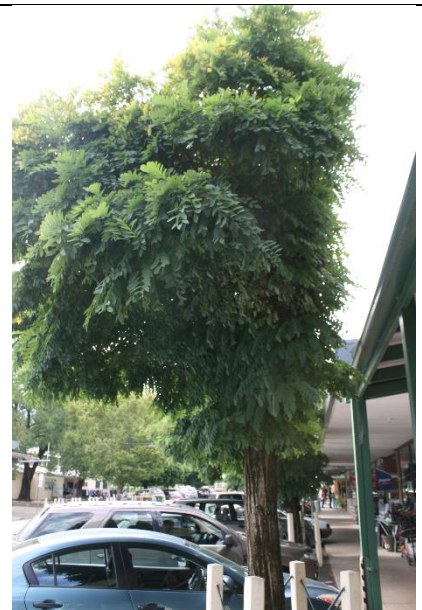
Tree 21: Asymmetrical canopy.

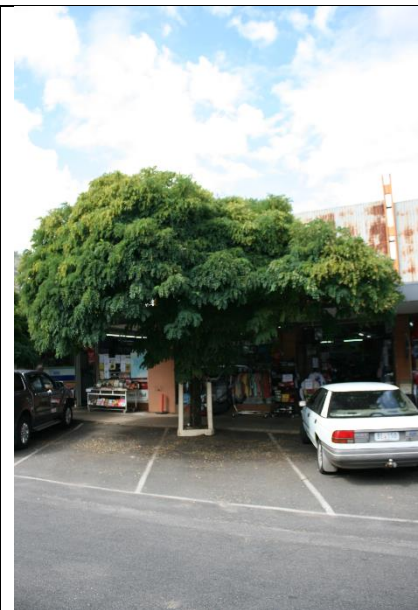
Tree 23: Extensive canopy.

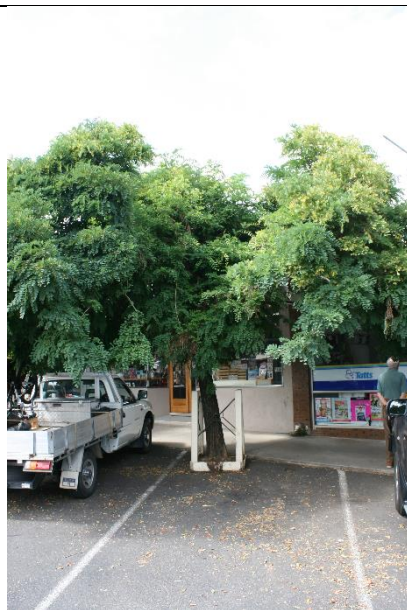
- 5.7 Tree 24 recently had a branch fail in the upper central canopy, causing other minor breakages and leaving a substantial hole in the canopy exterior. The failure was an isolated occurrence as a result of decay in the stem. The increased risk of further branch failure due to changed exposure to wind to the remaining canopy can be addressed through arboricultural pruning practices; namely reducing the canopy all over by 1m-1.5m.

Tree 24: Recent branch failure and associated hole in the canopy.

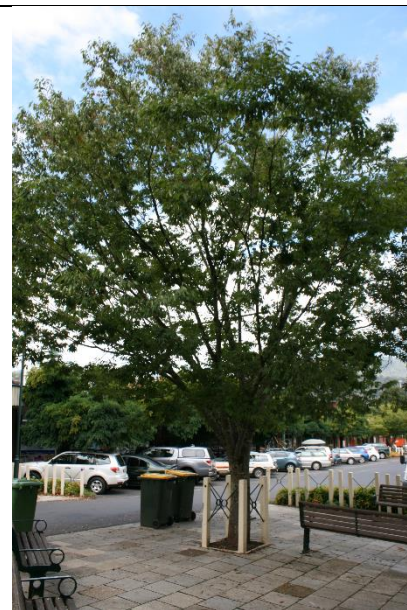
- 5.12 It was noted on the day of assessment that the canopy of tree 11, a European Nettle Tree, was rubbing on the Food Works delivery truck. Appropriate street clearance can be achieved through arboricultural pruning practices.

Tree 11: Celtis australis, illustrating size and location.
